A.V. Khapin¹, B.E. Makhiev¹

¹D. Serikbayev East Kazakhstan Technical University, Ust-Kamenogorsk, Kazakhstan

**ASSESSMENT OF PHYSICAL DETERIORATION
AND PREDICTED REMAINING LIFETIME OF METAL FRAMES
OF INDUSTRIAL BUILDINGS**

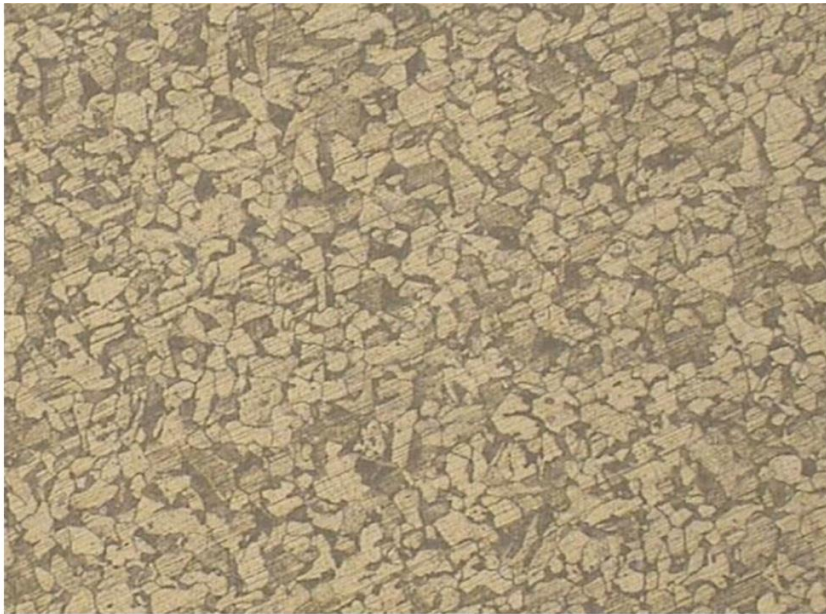
Figure 2. Microstructure of boiling steel

Boiling steel is characterized by a sharp heterogeneity of carbon, sulfur and phosphorus content, called liquation [13]. In addition to this drawback, there are defects in the crystal lattice – the absence of iron and carbon atoms in the nodes where they should be in accordance with the ideal structure of the metal. The absence of atoms is called vacancies [4].

dislocations that lead to the appearance of microcracks. Signs of such heterogeneity and concentration of dislocations can be seen in the photo provided by the laboratory of the analytical and technical control service of the enterprise (Figure 2).

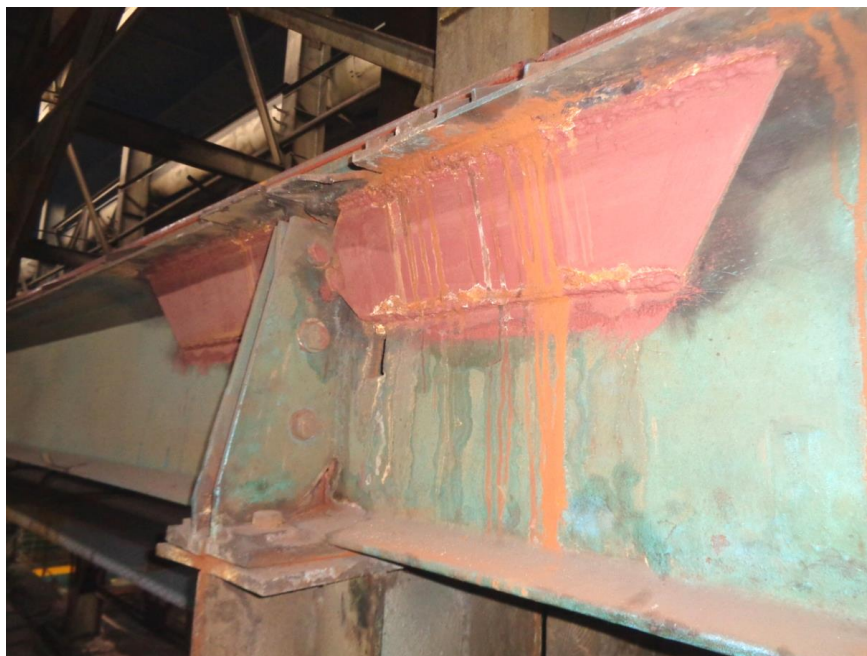
When examining the crane beams of the boiler room in 2012, cracks were found in the metal of the walls of the I-beams, which were reinforced by welding lamellae (Figure 3). In 2020, cracks appeared in the welds of the attachment points of the upper belts of crane beams to the columns in the welding department. This confirms the need to replace crane beams, since the period of operation of such structures is no more than 50 years.

Figure 3. Reinforcement of crane beams with cracks by lamellas

1. The need for priority replacement of crane beams. Sudden brittle destruction caused by aging of boiling steel and loss of elastic-plastic properties is dangerous for them. Usually the period of operation of such structures is no more than 50 years.
